CASE STUDY

Railway Utilities Replacement

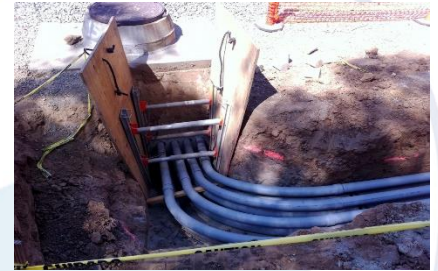
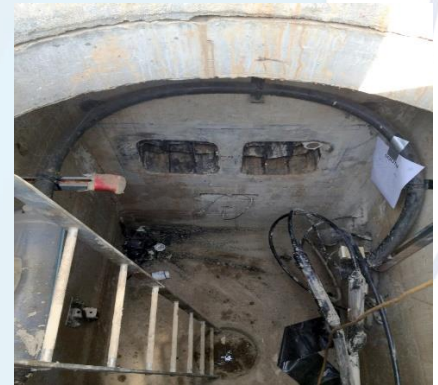
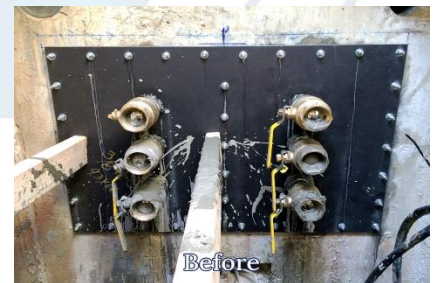
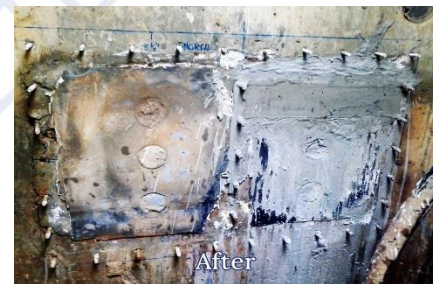
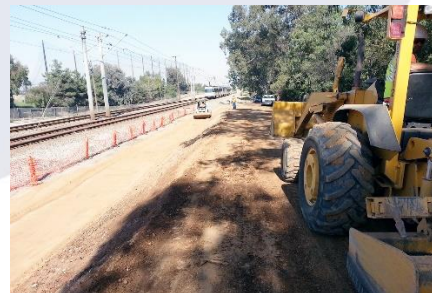
Due to the design of the old duct banks, E&E had to develop a custom pressure grouting methodology. The newly designed methodology consisted of two fabricated steel plates, each comprising six-ball valves. The assemblies were installed at each end of the ducts. By starting at the lowest point, with the lowest valves closed, grout was injected with the air expelling through the open valves until grout was detected at each, at which point they were closed until all voids were filled. Any surface daylighting was monitored and logged.
